What's Wrong With Our Hoist Ropes?

A GUIDE TO EXTENDING THE SERVICE LIFE OF ELEVATOR ROPES

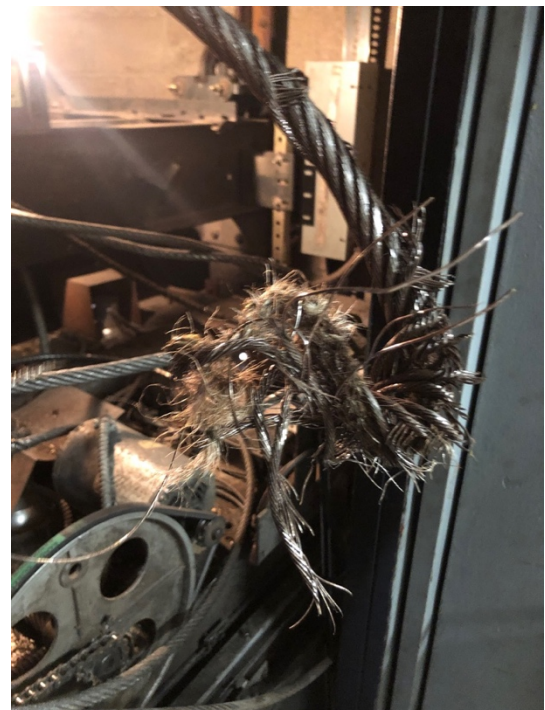
Fig. 1: When an elevator hoist rope fails

It's important for a building manager and their maintenance technician to understand what these ratings mean, as they are an indication that the hoist ropes in question may need to be replaced sooner than expected. Worse, some conditions may be signs of imminent catastrophic failure. (Figure 1). In some cases, the service life of the hoist ropes can be extended with better attention to maintenance. Often, unfortunately, the life of the existing ropes has already been irreversibly shortened, but steps can be taken to get more service life from the new replacement ropes.

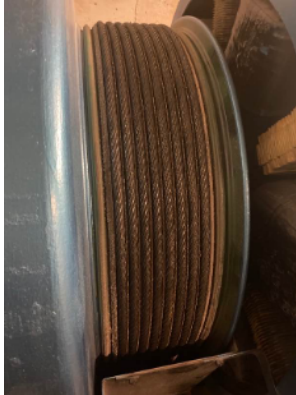
Figure 3 is a cross-section of rope where the fiber core has shrunk, with the strands wearing upon each other. Flattening of the contacting wires is easy to see in certain spots. This abrasion produces fine steel particles that are thrown to the surface of the rope and become a rust-colored dust known as rouge. Figure 4 is a photo of ropes passing over a drive sheave exhibiting significant rouging.

Fig. 4: Rouging

Rouge is not the same as surface rusting that might occur on the ropes if they were unlubricated and exposed to airborne moisture. Rouge is a loose powder that will eventually be found on other surfaces surrounding the hoisting machine. That powder is material that has been internally worn away from the rope strands, reducing the rope's cross-sectional area, reducing the strength of the rope, and consequently the rope factor of safety.

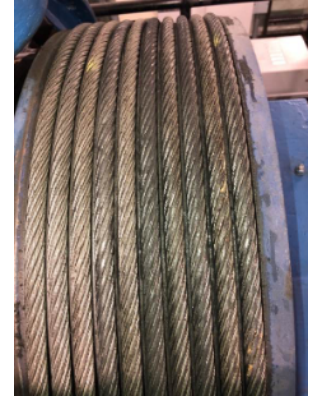
If the outer surfaces of the hoist ropes have been heavily re-lubricated after internal strand wear has started, the fine steel wear particles may contaminate the surface oil, along with dust from construction and other environmental contaminants. Figure 5 shows the appearance of buildup. Studies have shown that lubrication buildup can contain as much as 90 percent solid contaminants, and as much as 2 percent water.

Fig. 5: Buildup

Rouge and buildup are thus symptoms of internal damage that has already occurred within the rope. The prevention for this destructive process is timely application of the correct lubricating oil once it is noticed that the factory lubrication is being depleted. Experienced elevator maintenance personnel can check regularly to determine the right time and the proper method for re-lubricating ropes. The lubricant used must not contain solvents or detergents which can dissolve the remaining oil between the wires. New lubricant must be applied slowly over time using a wick type method.

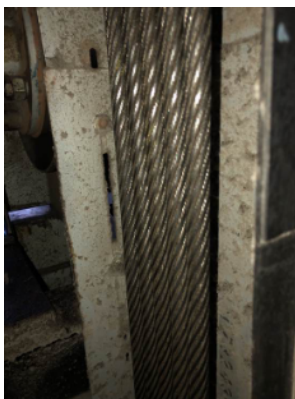
Crown wear refers to visible abrasion of the outer wires of a rope, as can be seen in figure 6. Significant crown wear results in thinning of the wires, leading to increased bending and fatigue stress as the rope passes over sheaves.

Fig. 6: Crown wear

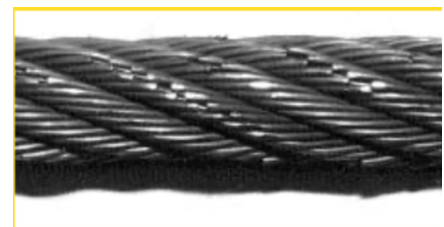
An eventual result can be fatigue breaks as seen in figure 7. There are many circumstances that might lead to accelerated crown wear, some of which relate to abnormal sheave groove wear. Maintenance can play a role in preventing premature crown wear by regular attention to the condition of drive sheave grooves, making measurements when needed. This is especially important before installing new ropes, since worn grooves may provide insufficient support to new ropes which will initially be of larger diameter than the retired ropes. This will lead to a short life for the new ropes.

Fig. 7: Crown fatigue breaks
